NAUGATUCK RIVER BASIN PLYMOUTH, CONNECTICUT

# PLYMOUTH RESERVOIR DAM CT 00286

PHASE I INSPECTION REPORT
NATIONAL DAM INSPECTION PROGRAM

**MAY 1981**

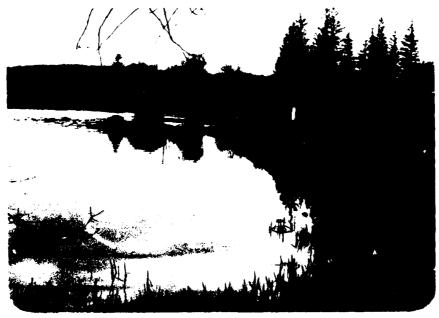
PHOTO NO. 2

CREST AND UPSTREAM SLOPE FROM RIGHT ABUTMENT.
NOTE LACK OF RIPRAP ABOVE WATER LEVEL.

- 2. Investigate the condition and adequacy of the upstream riprap and design repairs as required.
- 3. Investigate the condition of the intake gates and recommend necessary repairs to place them in operation.
- 4. Investigate the low level outlet or blowoff and design an upstream shutoff gate.

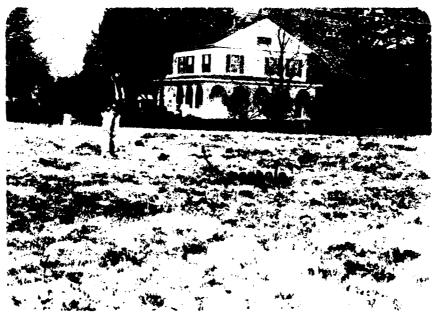
PHOTO NO. 12

EMERGENCY SPILLWAY AT LEFT END OF DAM.
